OTC 17498

## Cost Effective Mooring Integrity Management

Anthony D. Hall, Welaptega Marine Limited

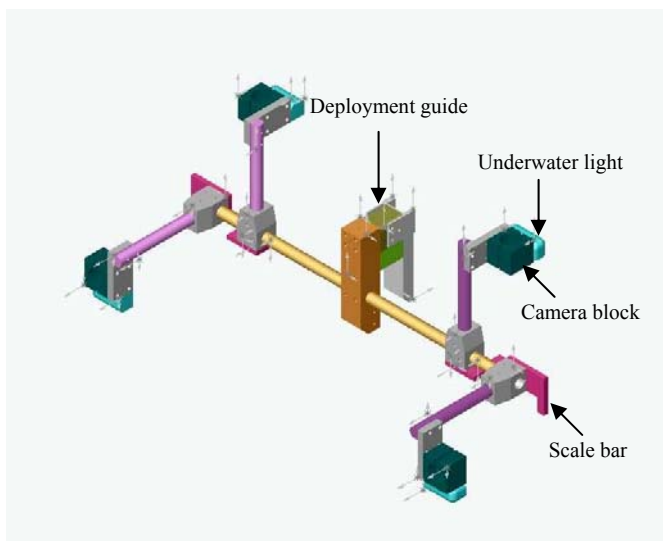
Figure 1 Illustration of 'optical caliper'- type mooring chain measurement system showing positions of cameras, lights and guides

**In-water chain measurement.** There have been a number of in-water ROV-deployed mooring chain measurement systems developed, but the only established system is an 'optical caliper' that uses video cameras and lights on a deployment frame (Figure 1) to collect scaled, high-resolution video footage of specific links.

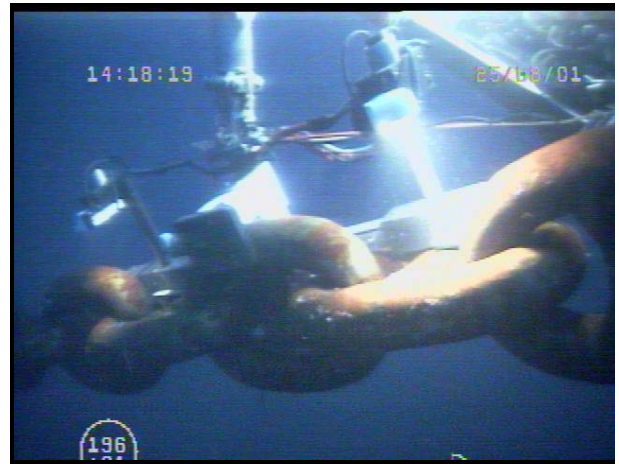
Figure 2 Video frame grab showing 'optical caliper'-type chain measurement system being deployed to a chain by ROV

The system is deployed by ROV (Figure 2) and measures the chain dimensions through software-based spatial analysis of synchronous video frame grabs from each of the cameras (Figure 3). The standard system measures two parameters, the length of specific numbers of chains, and the 'double diameter' at the contact point (grip zone) of adjacent links (Figure 3). Measurements are subsequently compared to established manufacturing and in-service chain standards<sup>3,4</sup> (Table 1). This type of system has no depth limitation except that of the onboard lights and cameras, and can be configured to measure difficult-to-access regions at the vessel interface and other types of mooring 'jewelry' such as connectors, shackles and kenter links.

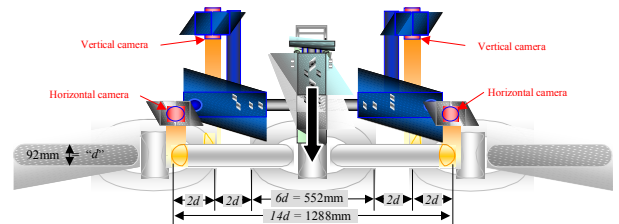
Figure 3 Illustration of orientation of 'optical caliper'-type chain measurement system to chain links during deployment, and chain parameters measured (in this case a 92mm studded chain)

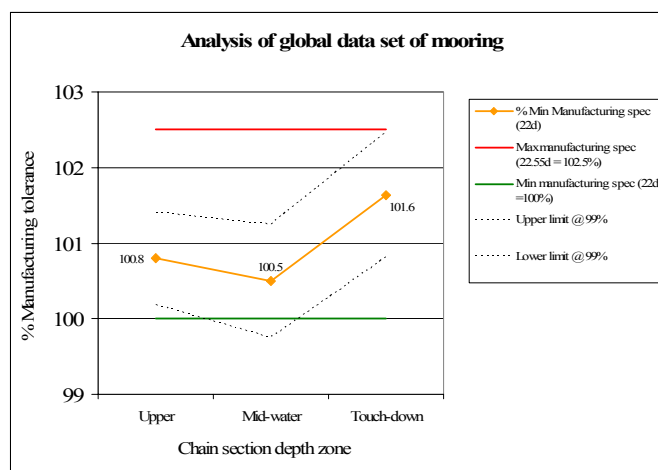
**Figure 4 Results of analysis of the global data set for lengths of chain sections of floating production systems pooled according to depth zone**

**Chain measurement.** Table 2 and Figure 4 present the results of an analysis of the accumulated global data set that has been collected using the optical caliper-type chain measurement system. Because of the differences between installations, particularly chain size and water depth, data are presented as percentages of the API minimum and maximum manufacturing specifications<sup>3</sup> (Table 1), and are grouped according to their relative position between the surface and the seabed.

The analysis shows a distinct trend to greater elongation at the seabed, followed by upper sections, and the mid-water sections. The seabed touchdown mean of 101.6% of the API minimum manufacturing specification, was 1.1% greater than the mid-water mean of 100.5% and 0.8% greater than the upper mean of 100.8%. This analysis is the first published evidence that there is a distinct correlation between depth zone and elongation of chain sections of the moorings of floating production systems.

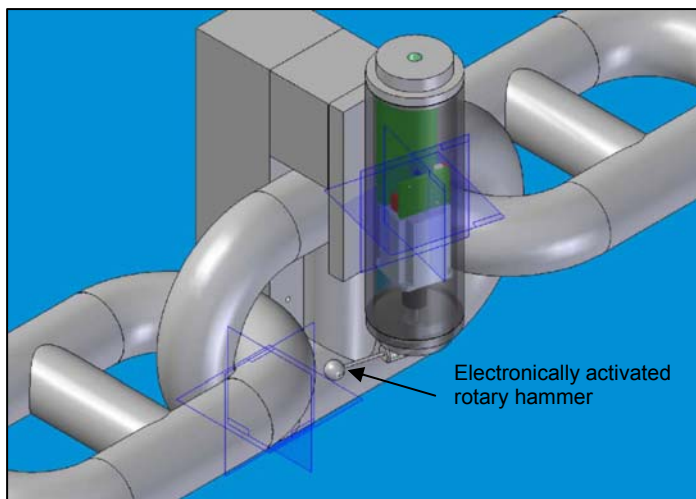
**Figure 5 Illustration of remote loose stud detection system showing orientation on chain, and the position of the rotary hammer**

**Loose stud detection.** As discussed in the preceding section on chain measurement, there are a range of reasons (e.g. cost, potential damage) why operators are disinclined to recover moorings for inspection, and that these have driven the development of ROV-deployable in-water inspection capabilities. One recently developed system is an ROV-deployed loose stud detection tool (Figure 5).

The remote system stud measurement operates on the same principle. An electronically activated hammer is used to hit the stud and two sensors - a hydrophone and a micro-accelerometer - record the resonance response to the impact. A software program then distinguishes between ‘loose’ and ‘tight’ responses.
